Use of ethylene-oxide gas sterilisation to terminate multidrug-resistant bacterial outbreaks linked to duodenoscopes

Lawrence F Muscarella

To cite: Muscarella LF. Use of ethylene-oxide gas sterilisation to terminate multidrug-resistant bacterial outbreaks linked to duodenoscopes. *BMJ Open Gastro* 2019;**6**:e000282. doi:10.1136/bmjgast-2019-000282

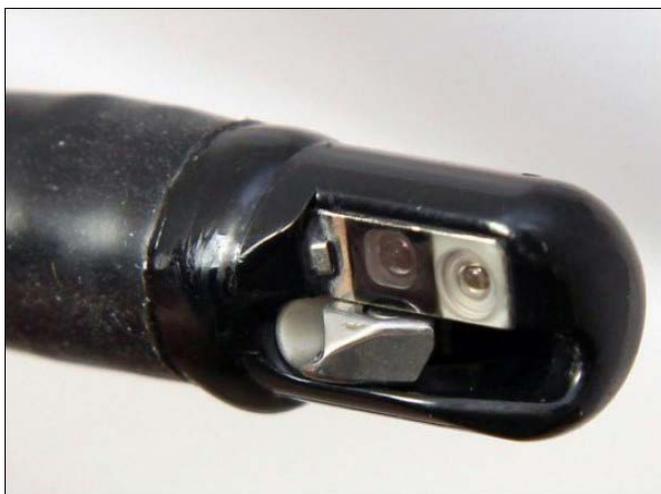
Figure 1 Pictured is the distal end of a duodenoscope featuring a sealed elevator-wire channel. Behind this mechanism is a recessed area. This mechanism connects to a knob on the duodenoscope's control head via a wire (neither visible) that is housed in the sealed elevator-wire channel (also not visible) (Source: FDA).

The duodenoscope's design: Displayed in figure 1, duodenoscopes feature a forceps elevator mechanism at their distal end that is used to help thread a catheter, guidewire or other accessory into the common biliary duct during ERCP.⁸ A long, enclosed wire connects this mechanism to a manually controlled knob on the duodenoscope's control section that is used to adjust this mechanism and alter the direction of the accessory during the procedure. In some older duodenoscope models, this wire is housed in a narrow channel that is open and requires reprocessing.^{8,9} In newer models, however, this elevator-wire channel is designed to be sealed at the duodenoscope's distal end obviating the channel's reprocessing.^{7,8,11}

While crucial to the success of ERCP, however, the FDA and others have reported that the design of the duodenoscope's forceps elevator mechanism and distal end can hinder cleaning.^{5,10,13,14} The FDA's February 2015 safety communication acknowledged "effective cleaning of all areas of the duodenoscope may not be possible."¹³ This communication further stated that moving parts of this elevator mechanism may remain contaminated after cleaning and disinfection. Others have similarly discussed the potential for the duodenoscope's distal end to remain contaminated despite being reprocessed according to duodenoscope reprocessing guidelines.^{7,9-14,37} In addition to other discussed factors, biofilms forming inside the duodenoscope and resisting removal with a cleaning brush can adversely impact the effectiveness of reprocessing.^{7,11,18,22,25}
